Remanufacturing CS-400E Component Locator

What follows is an explanation and differentiation of the remanufacturing process compared to "refurbished" machines.

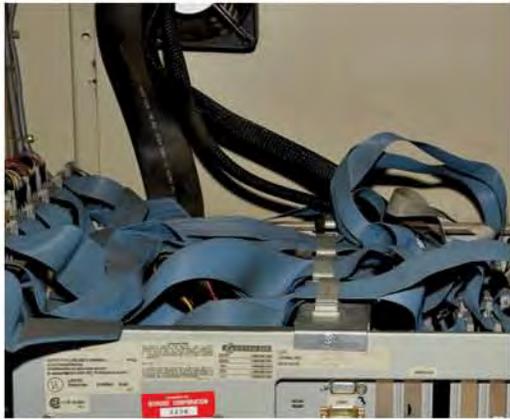
This is a machine that recently went through our remanufacturing process. This machine was in service just prior to being sent to us for remanufacturing. It is obvious this machine is in need of some TLC.

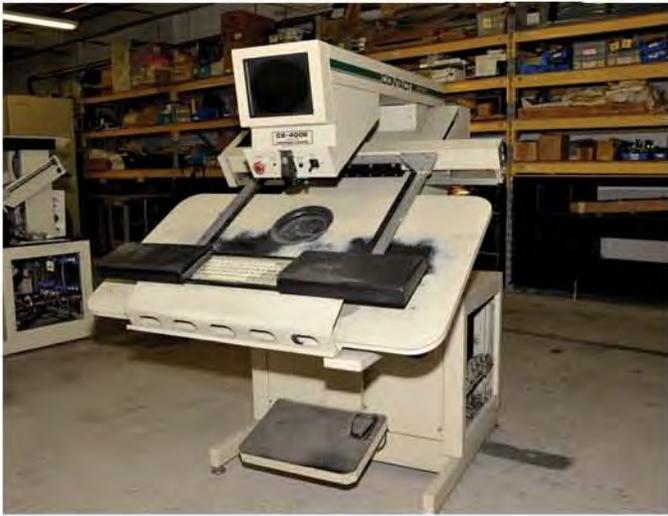
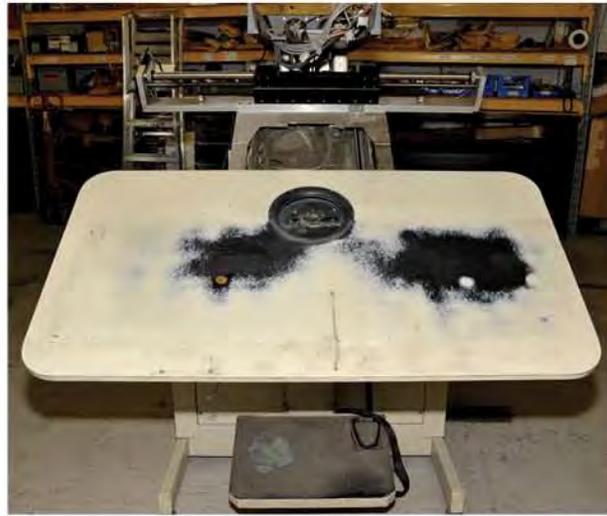
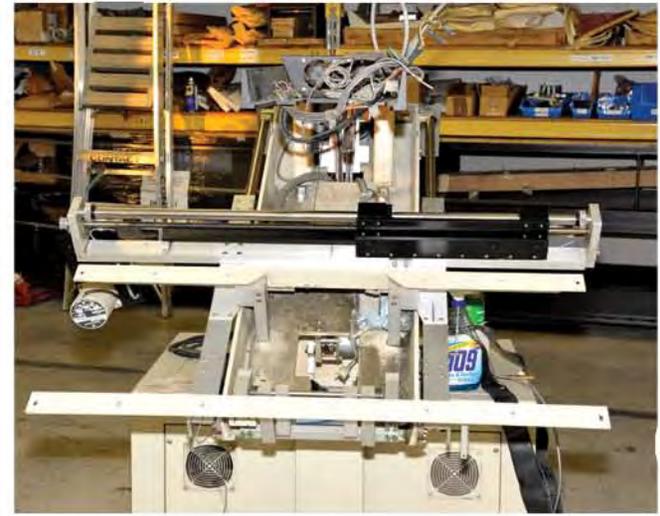
The first stage of the process involves a disembowelment of the machine.

We need to know what we are dealing with.

Major assemblies are removed for the remanufacturing process or to be replaced with the latest retrofits.

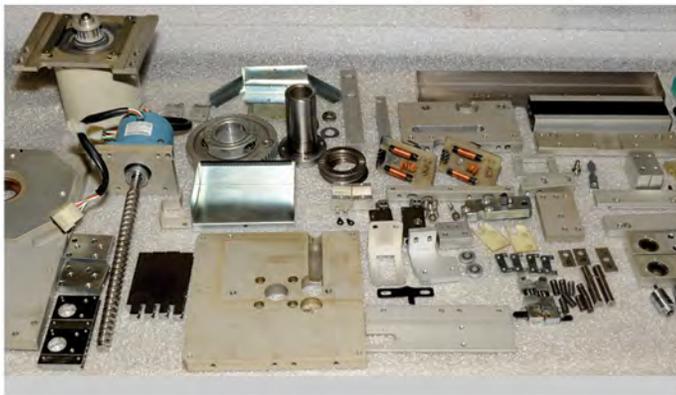
reassembled unit

The unit is reassembled to factory specifications

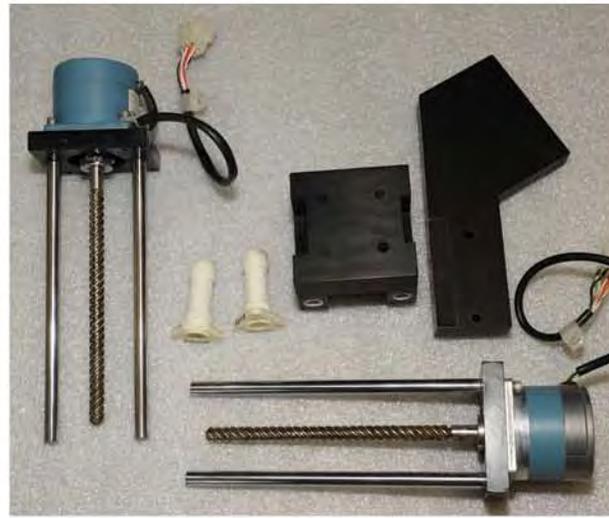
Subassemblies are disassembled down to the component state.

Every part is cleaned and re-lubricated if required. Faulty or worn parts are replaced.

The subassemblies are rebuilt to original manufacturing standards.

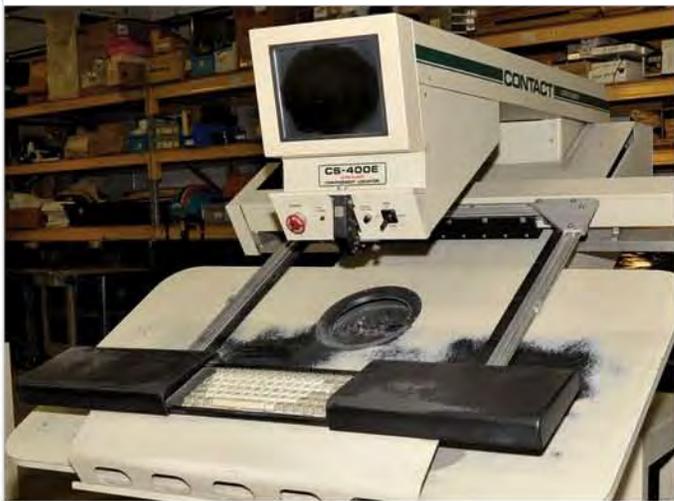
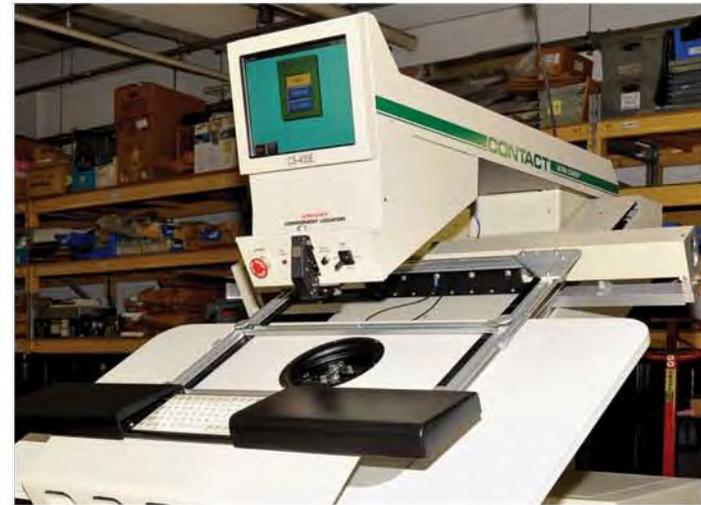
Major retrofits are done during the remanufacturing process.

In this case the machine was originally sold with the smaller CRT touch screen monitor but had a retrofit to an intermediate flat screen monitor.

The top channel was removed from the machine and brought into our machine shop to be modified to accept the latest monitor upgrade and thus further "futureproof" the machine.

This cannot be done in the field.

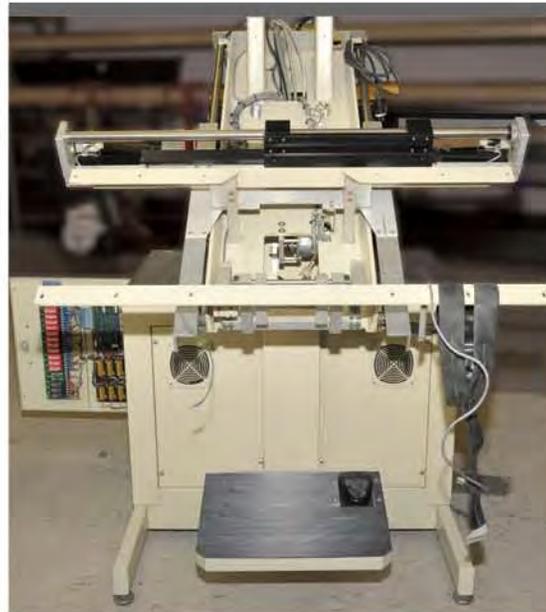
The monitor was discolored so the latest retrofit was installed.

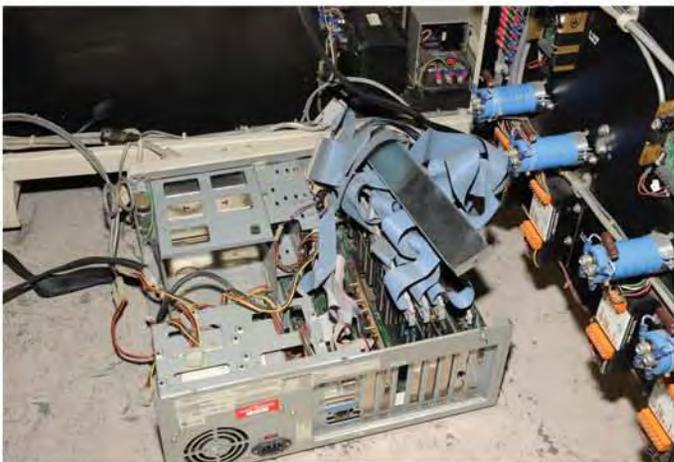
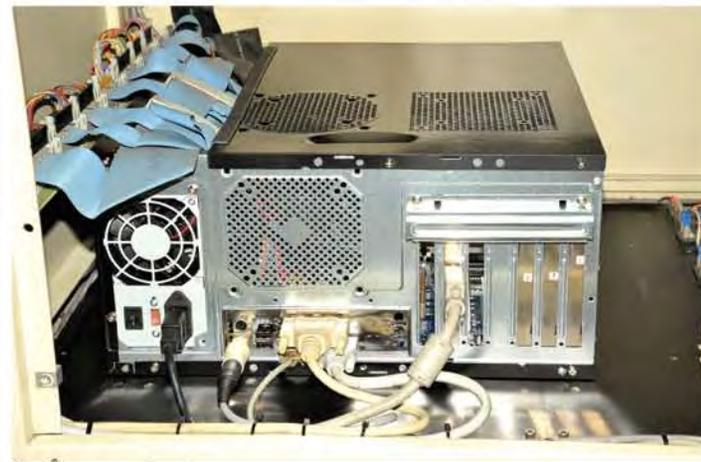
Although the PC was still functional it was determined that it was too old to leave in service. Therefore the latest computer upgrade was installed.

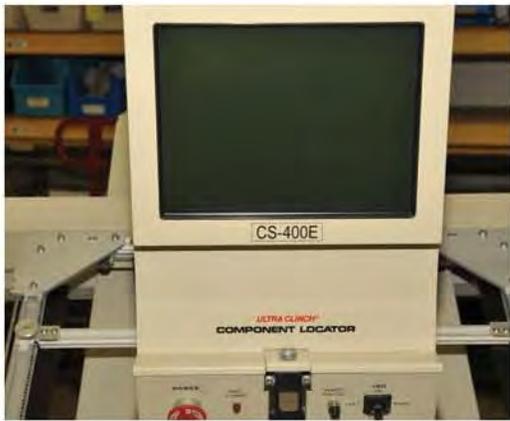
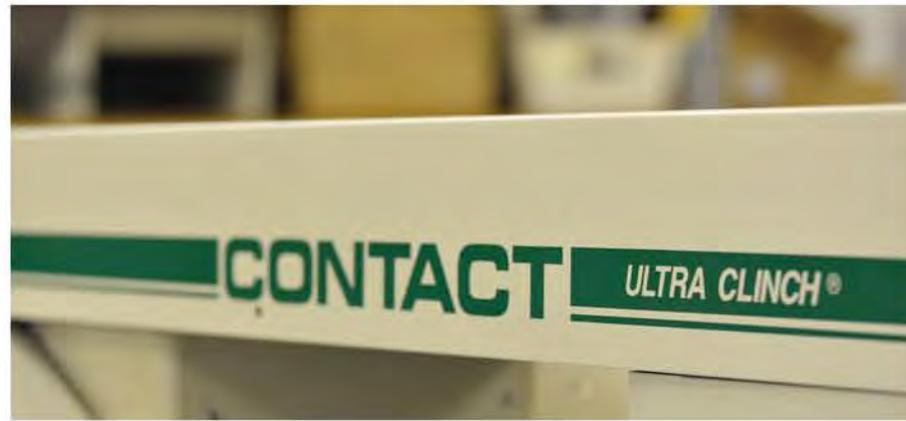
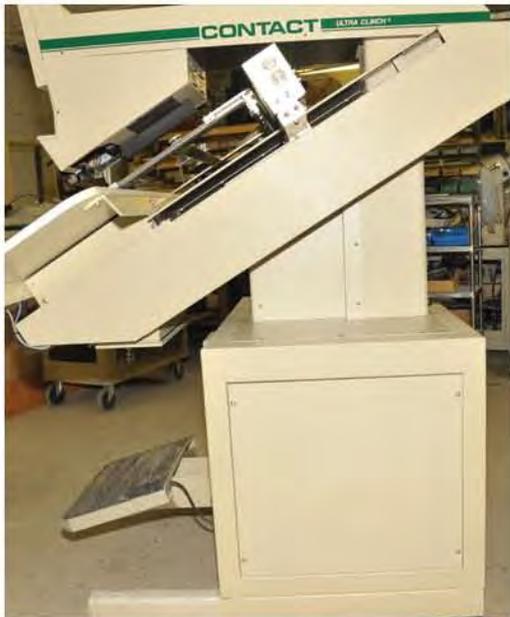
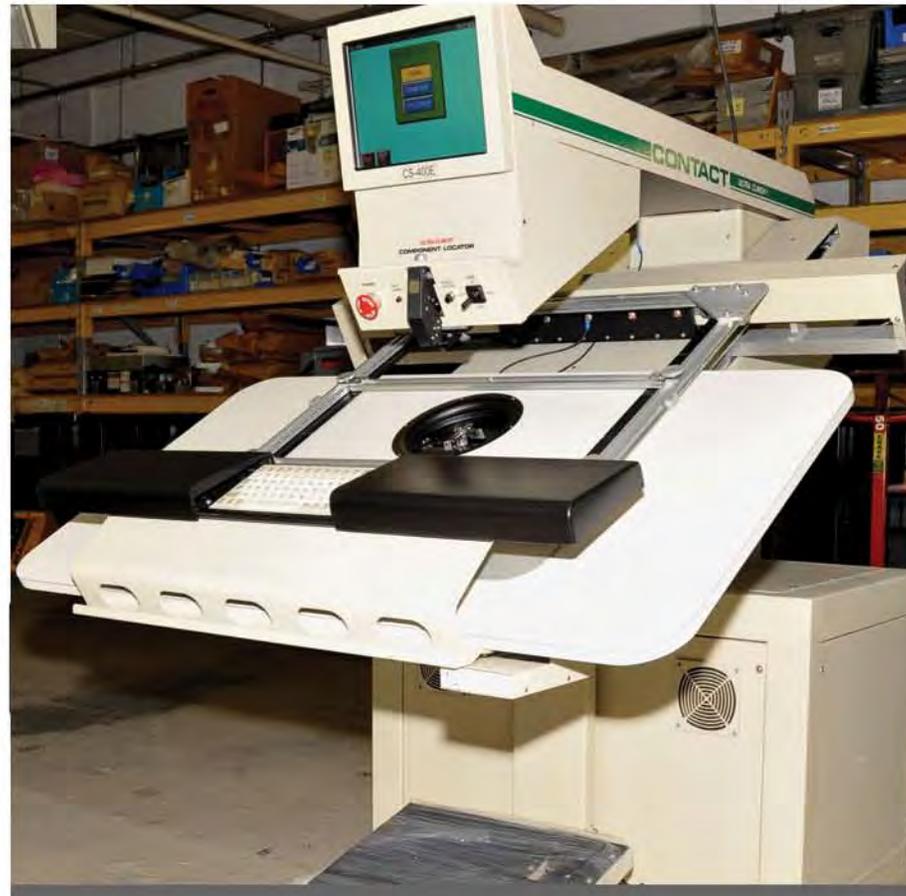
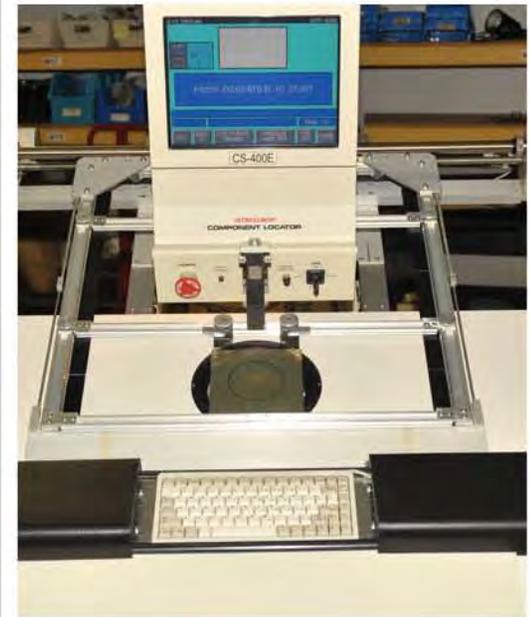
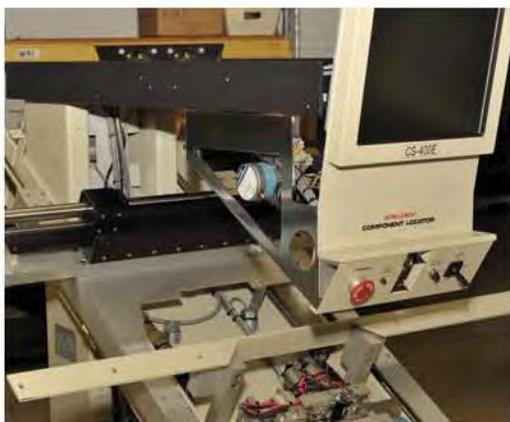
The end result is a virtually new machine with warranty but without the new machine price tag.
Contact sales@versatecsolutions.com for pricing and availability.
